NEW VIBURNUM TAILINGS DAM  
IRON COUNTY, MISSOURI  
MO 31231

## PHASE 1 INSPECTION REPORT NATIONAL DAM SAFETY INSPECTION

PREPARED BY: U.S. ARMY ENGINEER DISTRICT, ST. LOUIS

APRIL 1981

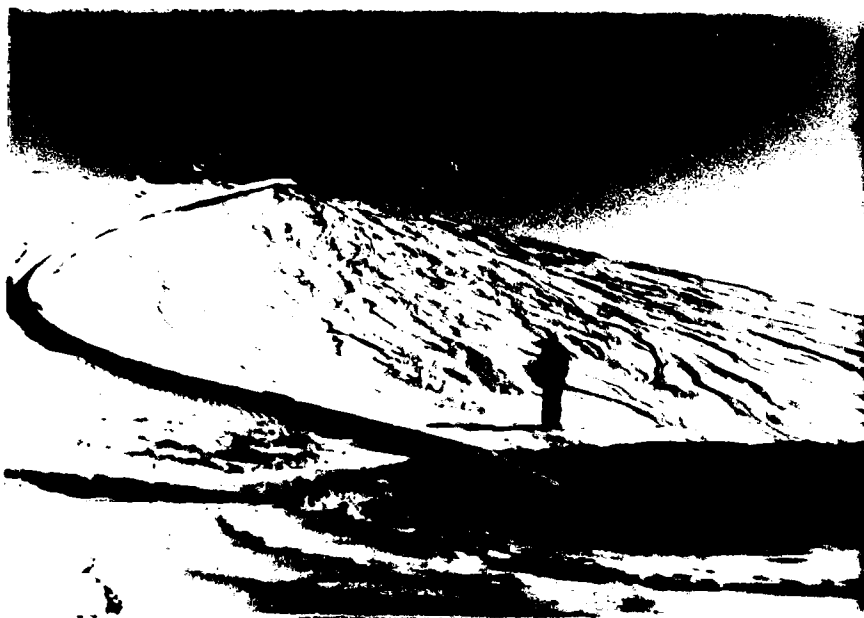
4. Discharge pipe from the cyclone along the upstream face of the embankment.

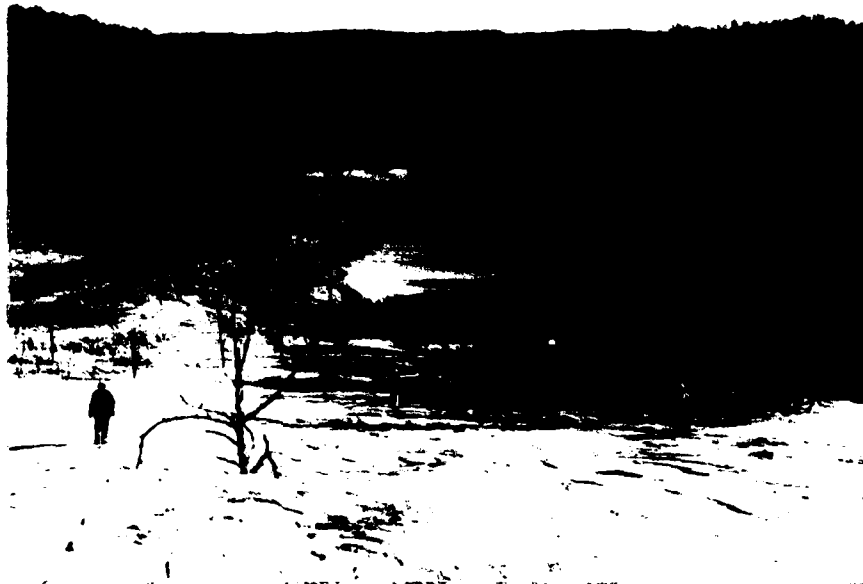
is provided. The deep erosion noted on the lower exposed portion of the upstream face of the embankment does not threaten the stability of the dam because this upstream slope is relatively flat. The uncontrolled seepage and associated slumping noted at the downstream toe of the dam is potentially much more serious as it is indicative of continued unsatisfactory drainage at that location. This indication is strongly confirmed by the evidence of past sinkhole activity.

7. Downstream toe of the embankment. Looking northeast. Note the tailings up to the settling pond in the background and the buried trees. Also note seepage erosion area at the immediate toe of the dam.

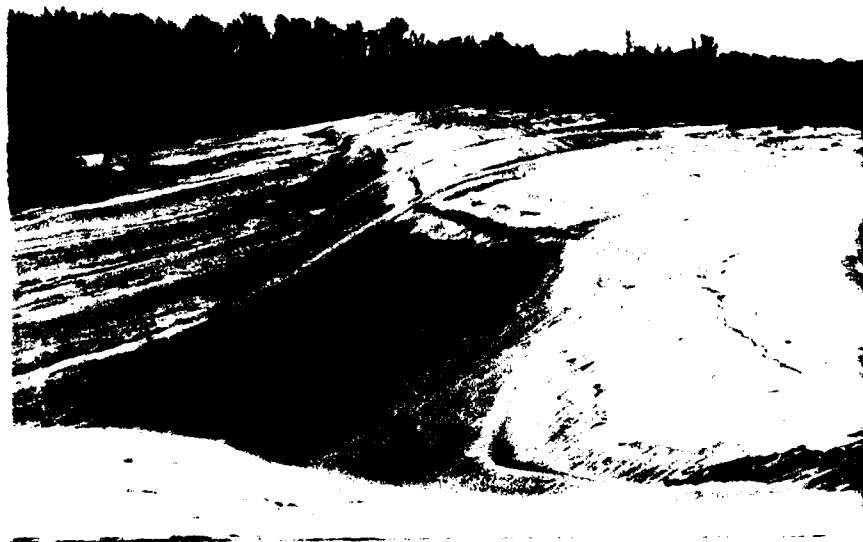
8. Aeolian dune face along downstream face of the right end of the embankment. Looking southeast.

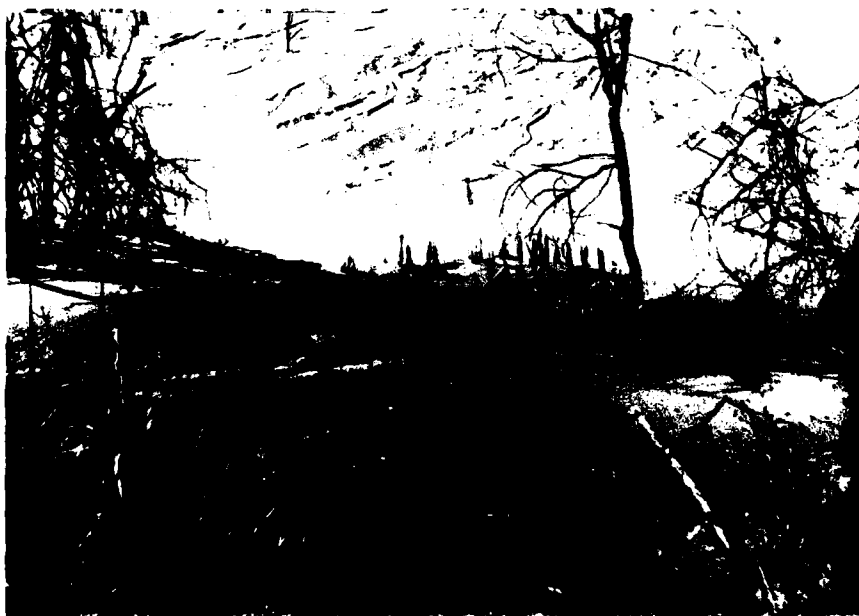
Uncontrolled seepage at the downstream toe of the dam did not appear at that time to be seriously detrimental since no evidence of internal erosion was found and only small slumping was identified. Coupled with the evidence of the existence of a sinkhole only four months before the inspection and the apparent renewal of sinkhole development several months later, however, this seepage becomes of much more concern, as it indicates that there is a potential for piping (internal erosion) of the dam. The structural stability of the dam can be seriously affected if piping occurs at the toe or under the downstream slope of the dam. It is particularly important to note that the elevations of the present and future spillways dictate that the operating level of the reservoir will in the future be at least 20 ft higher than any condition experienced by this embankment to date. This could have very serious seepage and stability consequences and should be a subject of further study.

10. Seepage at the toe of the downstream face of the embankment near the left abutment.
